Critical Over-the-Air Vulnerabilities of Hoymiles Microinverters

Benedikt Heinz <hunz@mailbox.org>*

July 6, 2026

Document version: 0.1

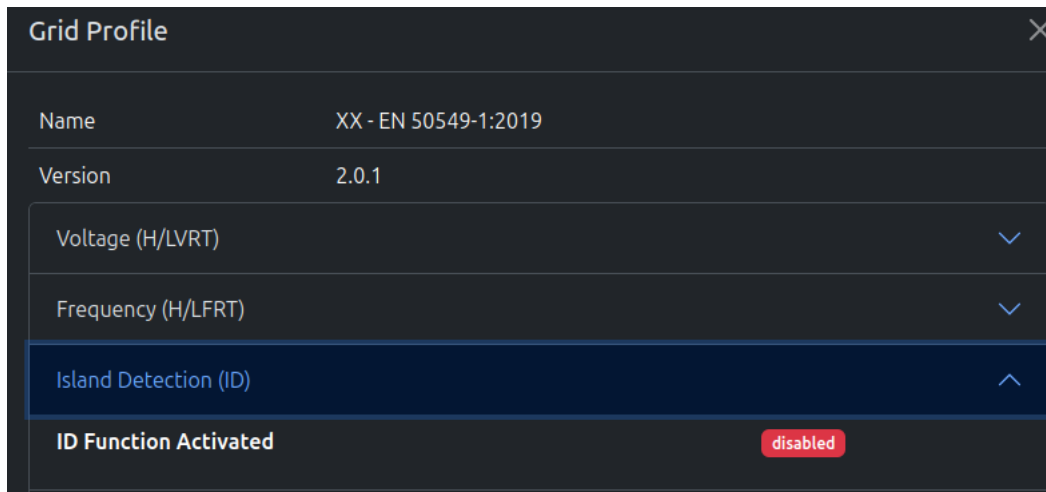
According to the reverse engineered Grid Profile structure, Islanding Detection can be enabled or disabled with a single bit of the profile. This bit was flipped in a copy of the regular profile:

The inverter response indicates successful reception and adoption of a valid Grid Profile. The DSP of the inverter also saved the new profile to the I²C EEPROM. (This was monitored using a logic analyzer.)

When the active Grid Profile was read with OpenDTU, the manipulated profile was shown with Islanding Detection disabled. A screenshot of this is presented in figure 1. Apart from this, no electrical tests regarding Islanding Detection behavior were made with the inverter because the author does not have a suitable test setup for this.⁶

Figure 1: OpenDTU readback of modified Grid Profile (Islanding Detection disabled)

Digital signatures based on public-key cryptography are necessary to ensure the authenticity and integrity of firmware images and Grid Profiles. Additionally, both Grid Profile changes and firmware updates should only be possible when requested/initiated by the device owner. This could be implemented with a physical acknowledgement/confirmation.⁸ 153
154
155
156
157
